CENTRAL INTELLIGENCE AGENCY

COUNTRY USSR (Leningrad Oblast)

SUBJECT 1. Ship Construction in Leningrad Shipyards
2. Photograph of the Baltic and Krylov Shipyards

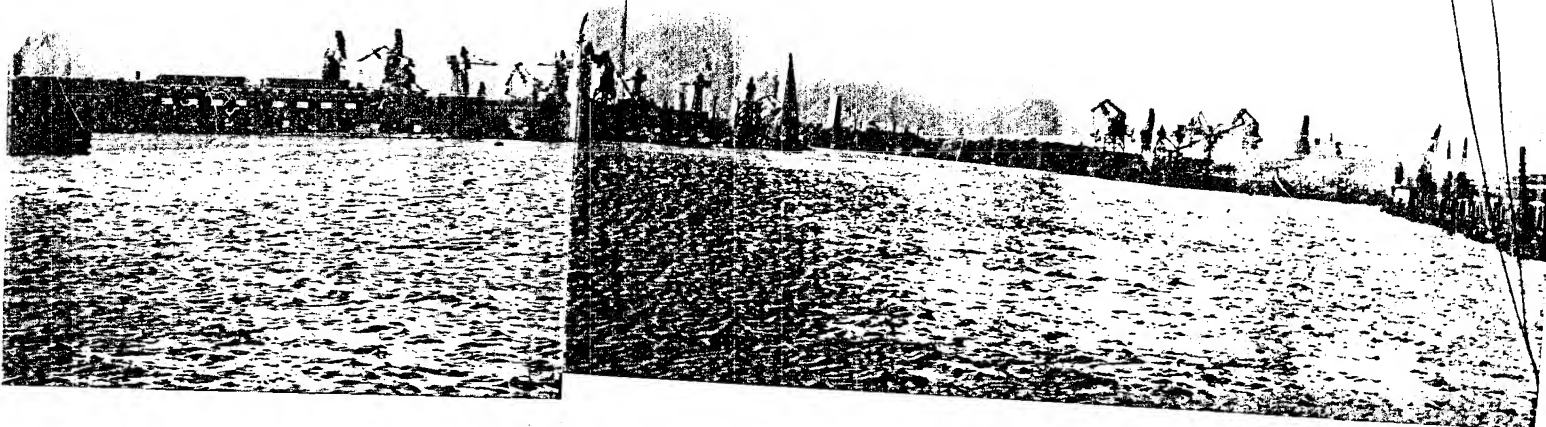
5. [redacted] showing the Baltic Shipyard at the left, the Krylov Shipyard at the right, and a submarine at the far left, taken [redacted]

USSR Leningrad 59 55 N 30 15 E
BALTIC SHIPYARD AT LEFT, KRYLOV SHIPYARD (FORMERLY MARTI SHIPYARD) AT RIGHT.
SUBMARINE ~~PLANT~~ AT FAR LEFT.
